4. Existing Conditions

One of the basic tasks in a master planning effort is to document existing conditions. We must know what we have before we establish what we need. This chapter summarizes extensive documentation of the State's Augusta physical resources.

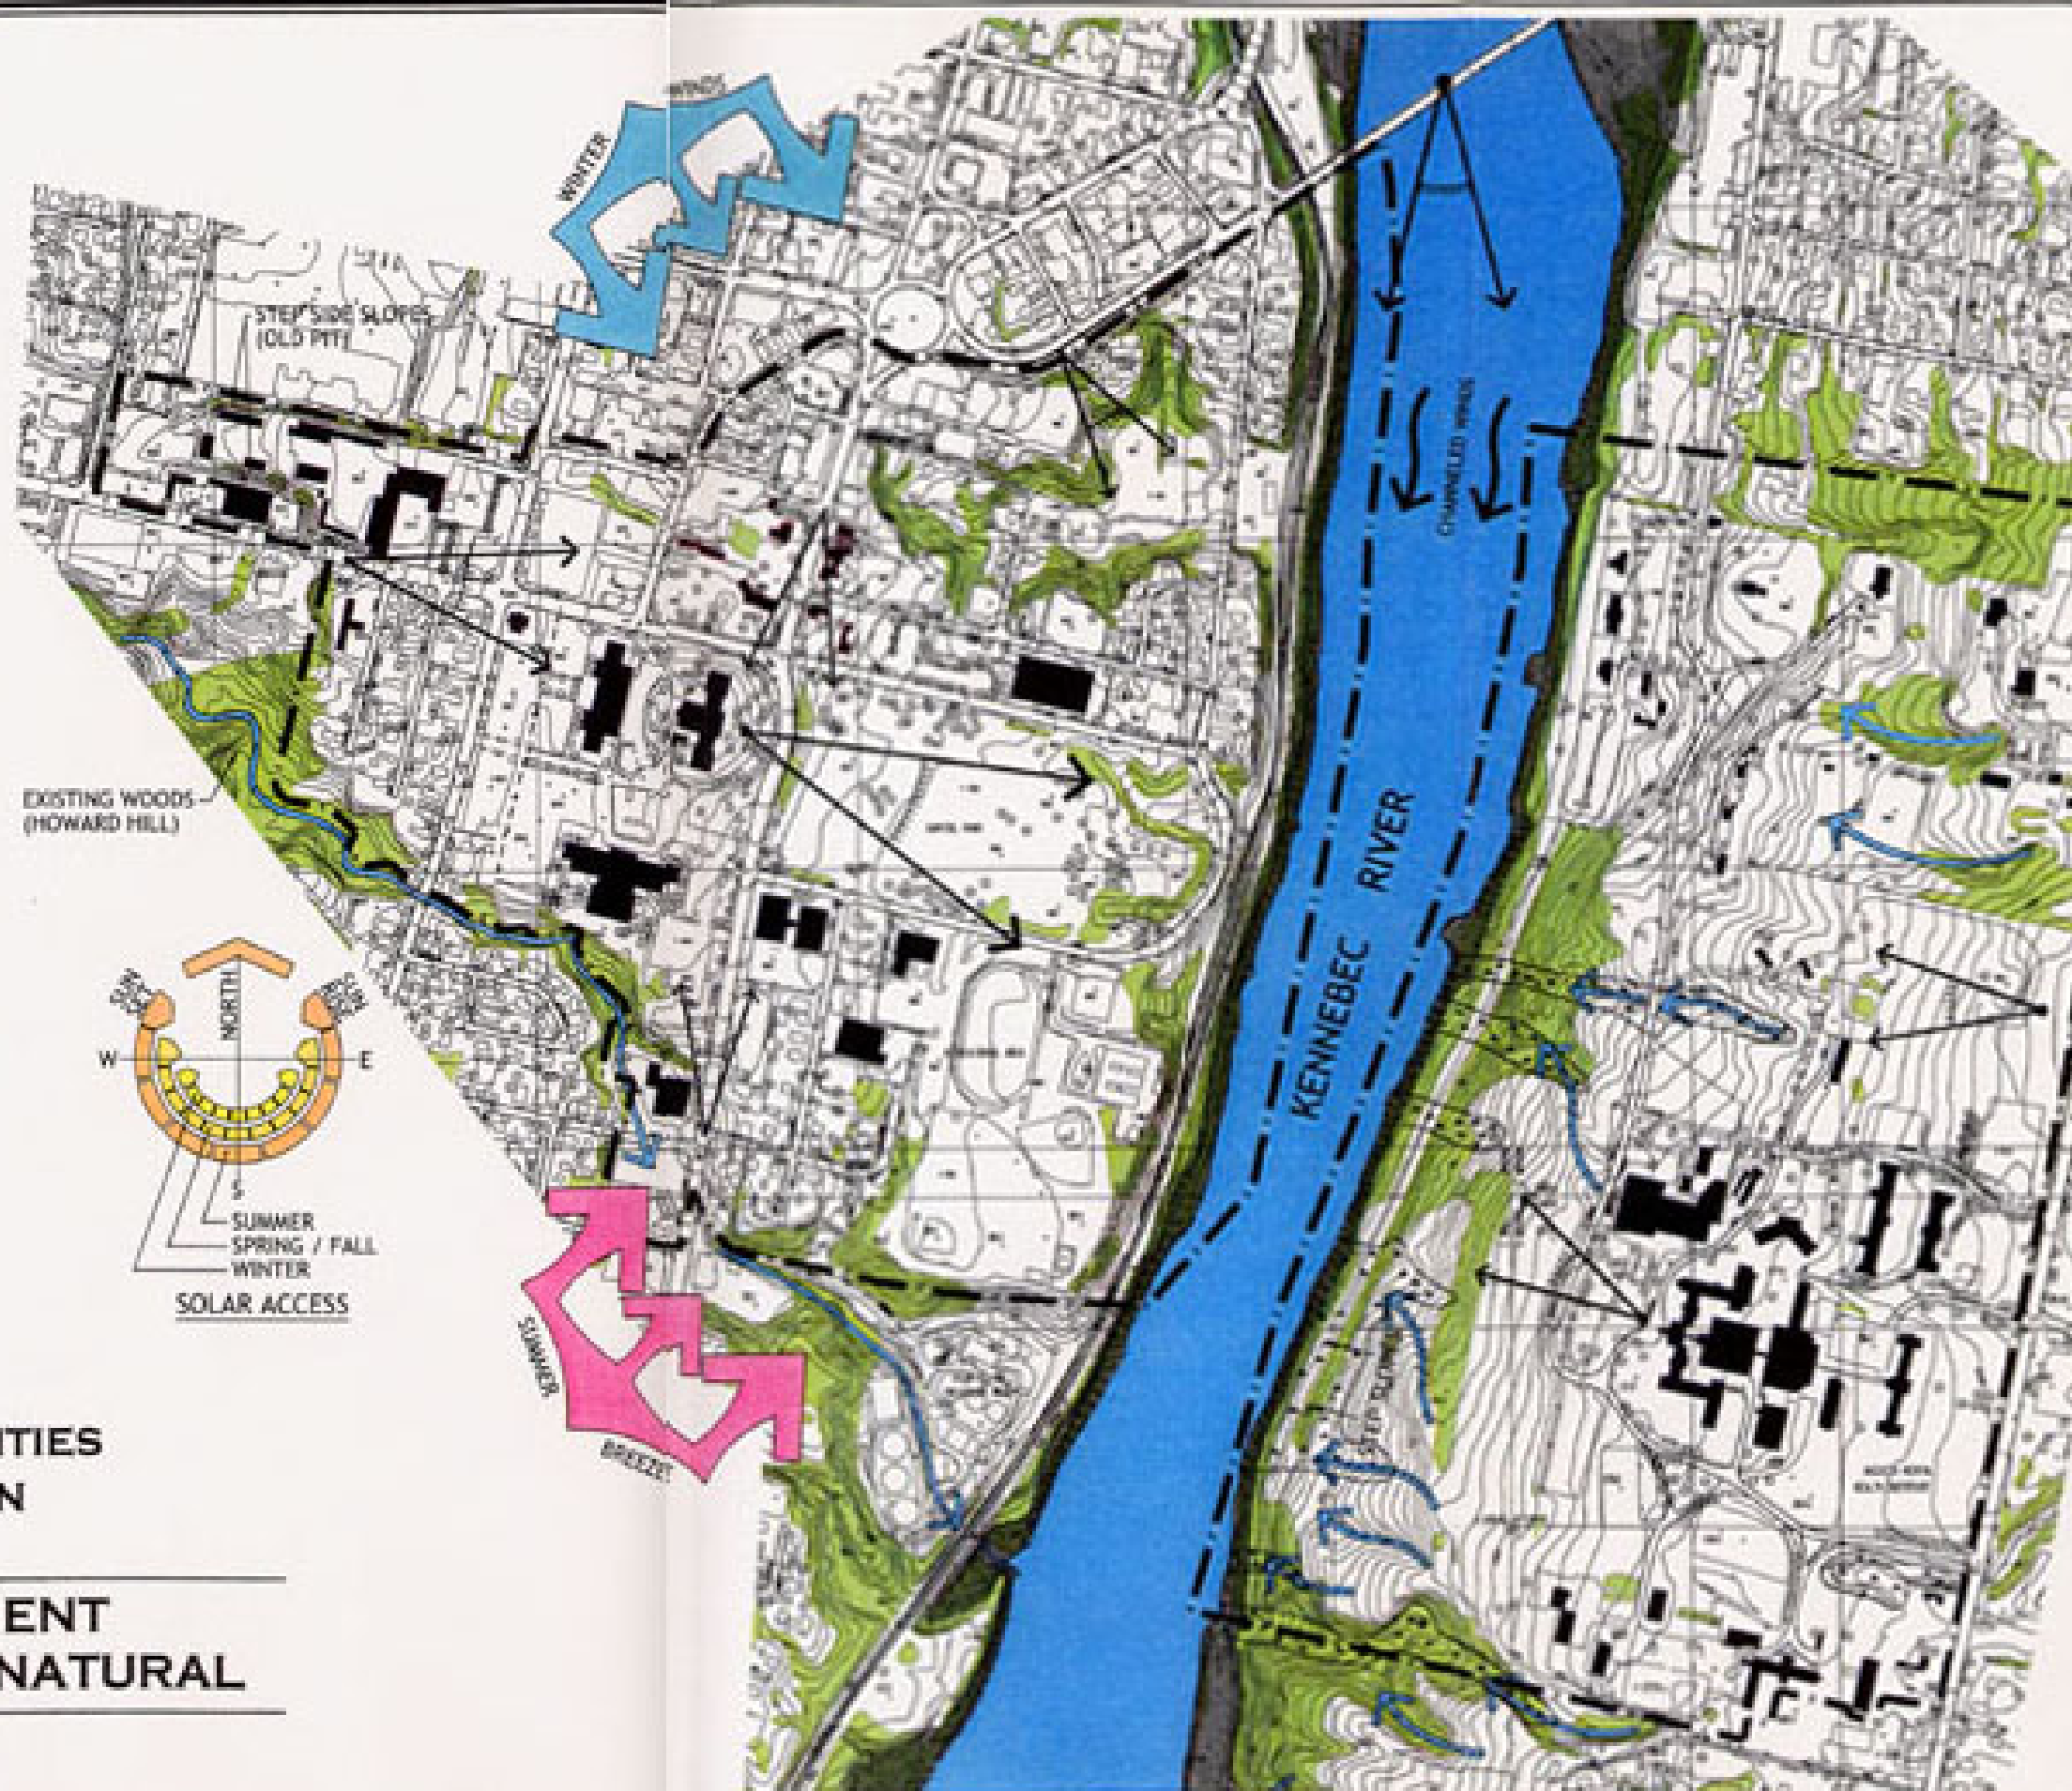
DEVELOPMENT FACTORS - NATURAL

lower portions of the Arsenal and a pedestrian “greenway” running alongside the river fall within this area. In general, the zone consists of steep, wooded riverbank conditions and, as such, is not suitable for development.

The East Campus with a primarily westward facing slope orientation is exposed to both winter and summer winds. Winter conditions can be harsh; thus the use of vegetative or architectural screening and buffering is recommended. *(Please refer to Development Factors – Natural Map)*
